FLORIDA FISH AND WILDLIFE CONSERVATION COMMISSION
DIVISION OF LAW ENFORCEMENT
INCIDENT NUMBER FWSB-16-OFF-12502

CASE SUMMARY / INCIDENT REPORT

REPORT #: FWSB-16-OFF-12052

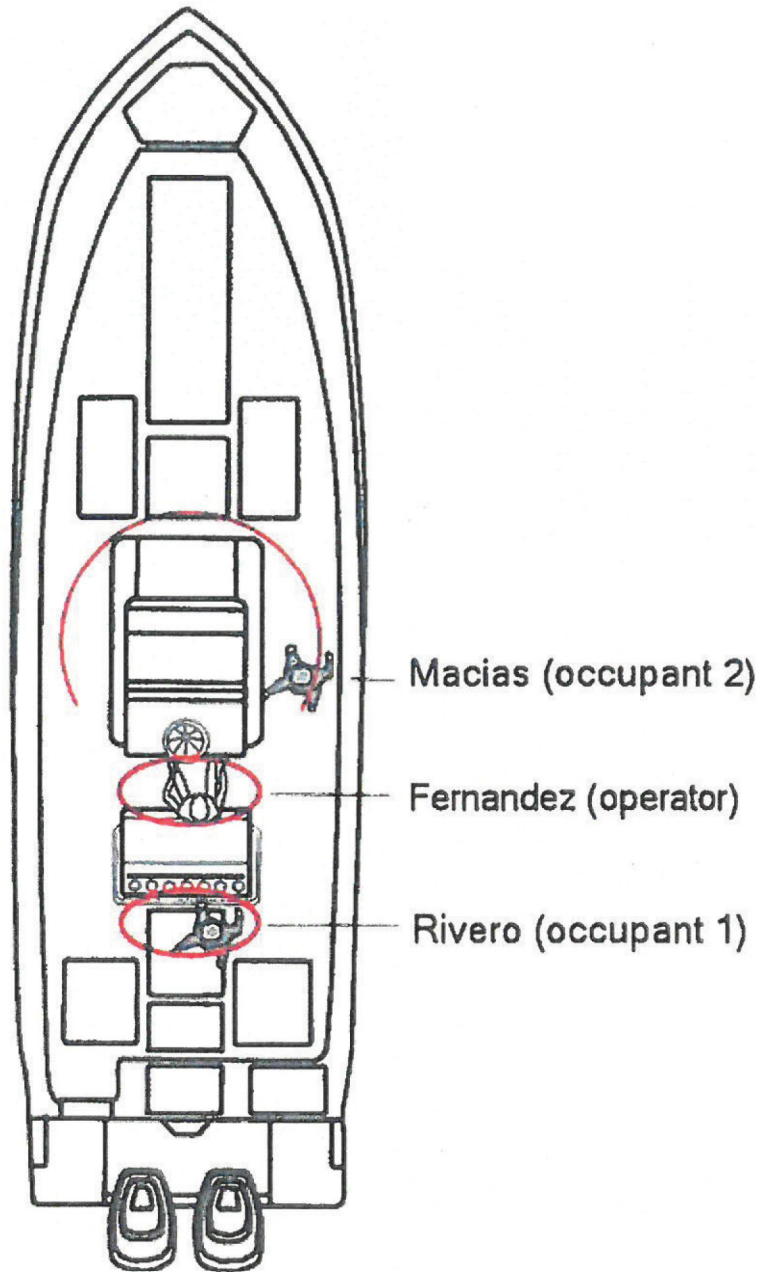
V-1 Seating Diagram:

*The probable seating location of occupants was based on physical evidence collected during this investigation.

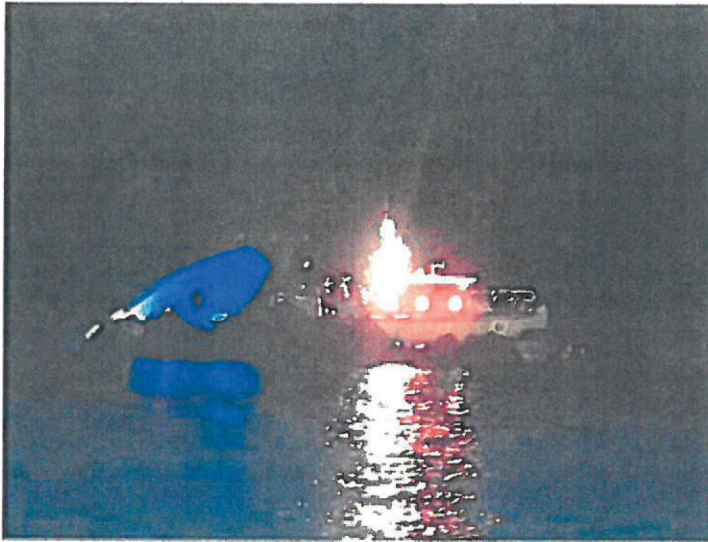
Fig. 2. V-1 view from south side of north jetty

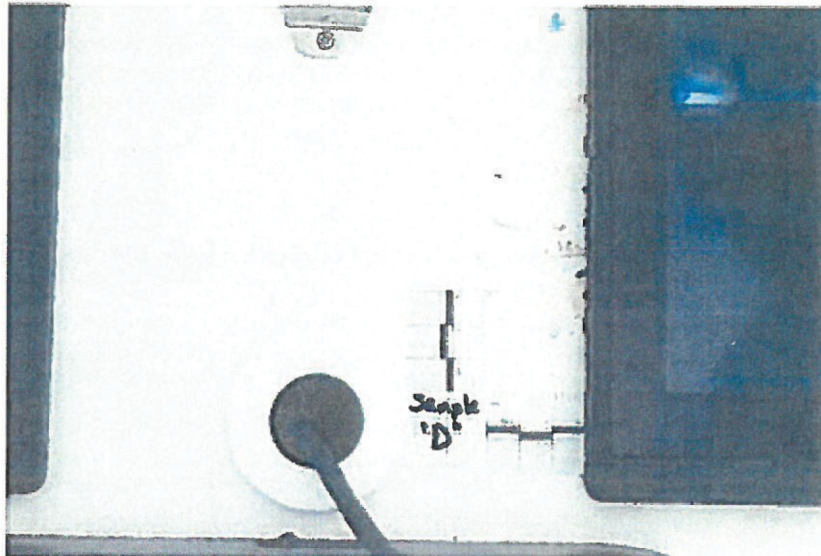
Fig. 28. Damage cause by MDFRD Halligan tool.

Since we were not aware of the MDFRD diver's actions at the time, when MBPD Crime Scene Technician Amy processed V-1, a possible blood sample was taken from between the GPS unit as "Swab from Sample D". After having watched the video, as would be expected, sample "D" came back negative for DNA.

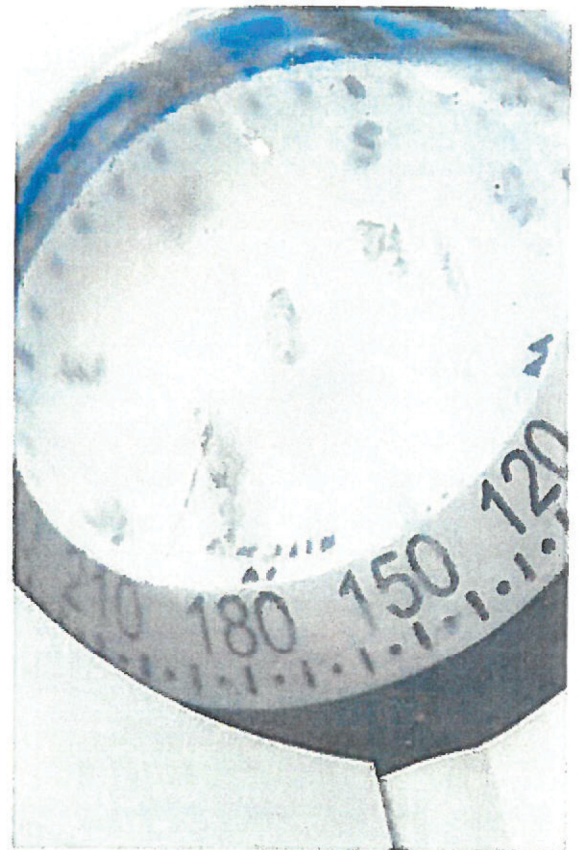
Fig. 36. Close up of chips.
